Mark Cramer Inspection Services, Inc.

Building Inspection Report

Report Number: 90002785

Address: 123 Any Street, Clearwater FL 33785

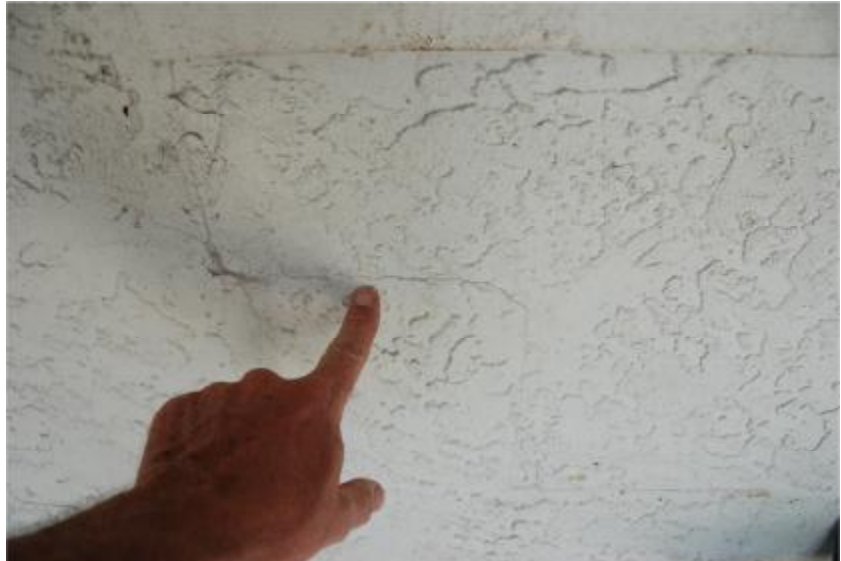
Hairline size step shaped and vertical cracks were observed in the exterior concrete block walls. These are usually the result of settlement, and do not appear to indicate any structural problems at present. In a perfect world, properly constructed foundations and concrete block walls would not crack. However, cracking of this type is found in more than 75% of the homes we inspect. Usually the cracking does not advance beyond a minor stage, but the causes of the movement cannot be determined from visual inspection. Should any of this

cracking advance considerably in size in the future, further investigation consisting of foundation excavation, inspection, and soil borings would be warranted, and repairs could become necessary.

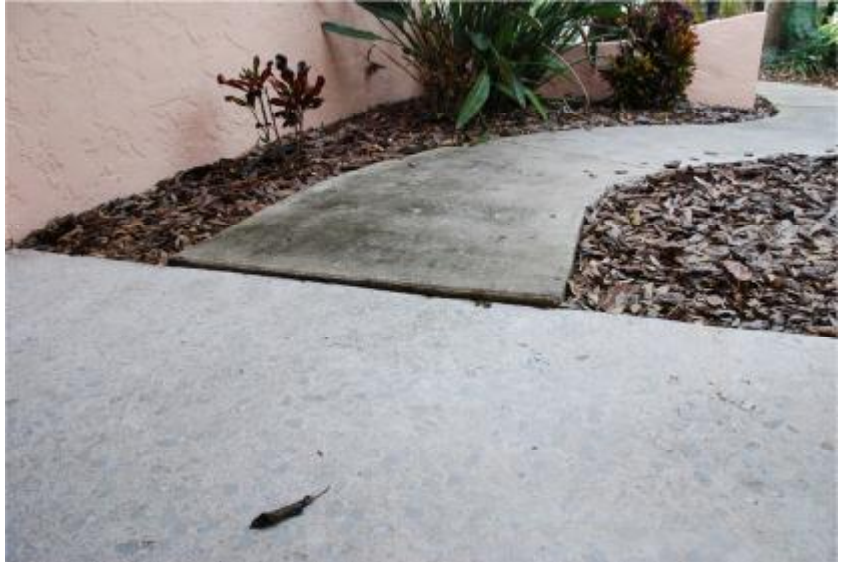
Safety Concern At the front entry, the sidewalk is higher than the front porch slab, creating a tripping hazard. Falling is the #1 cause of injury in the home. Grind down the sidewalk to eliminate this hazard.

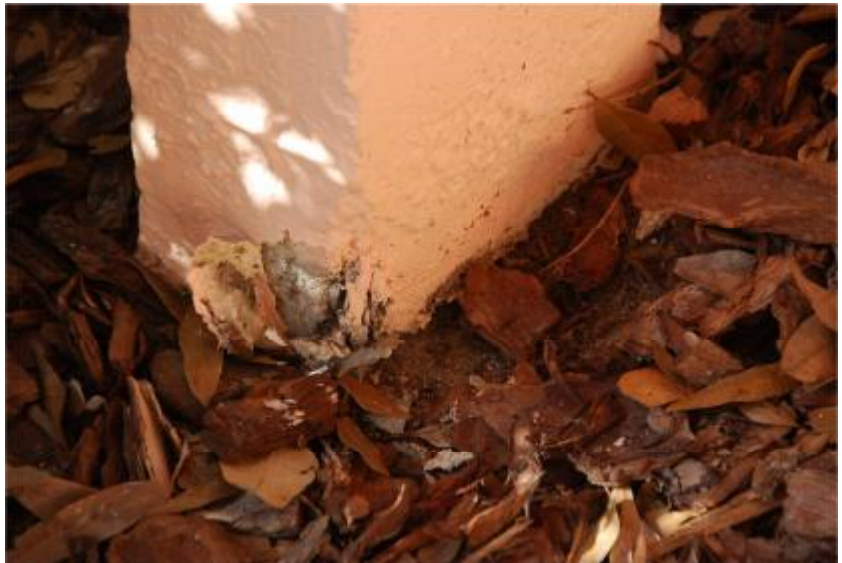
Minor Repair Minor damage is present to stucco at the base of some of the front porch columns. Repairs are needed, but not urgent.

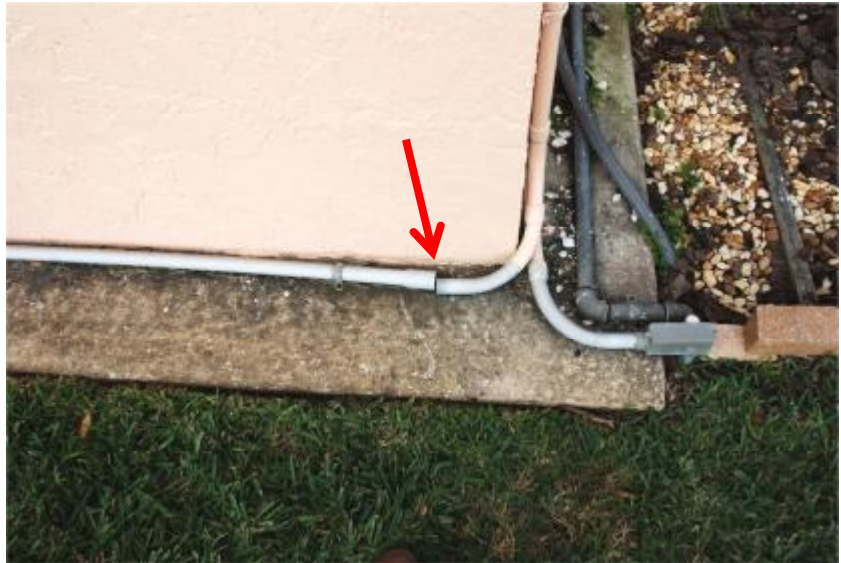
Safety Concern Plastic electrical conduit is separated at the NE corner of the house. Long runs of plastic conduit need expansion joints to prevent this.

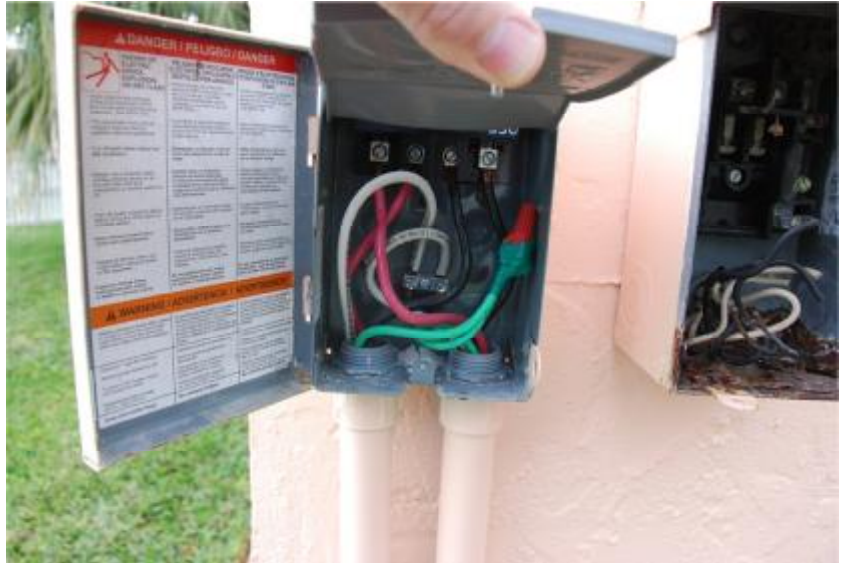
Safety Concern The disconnect at the NE corner of the house has the neutral bonded to the metal case. The equipment ground isn't. This ground should be bonded to the case, the neutral should not.

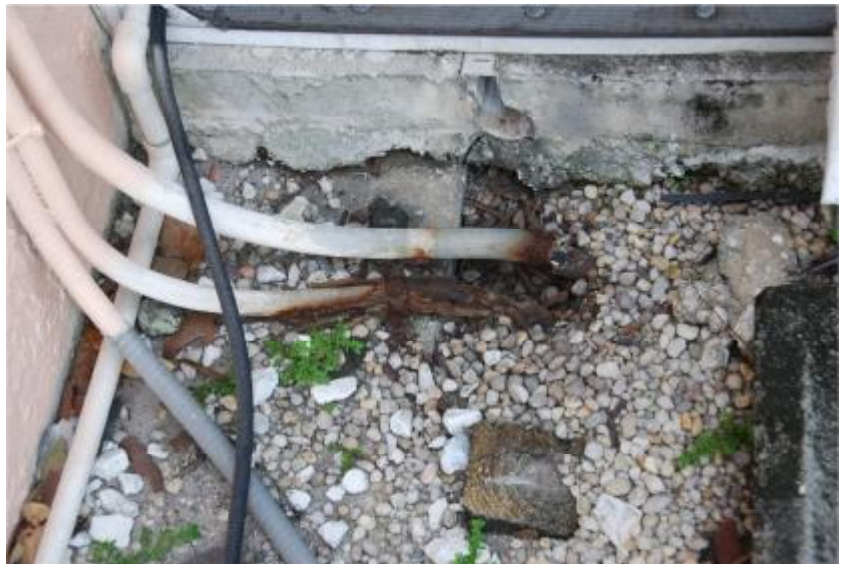
Safety Concern Metal conduit East of the screen cage is heavily corroded. It needs replacement.

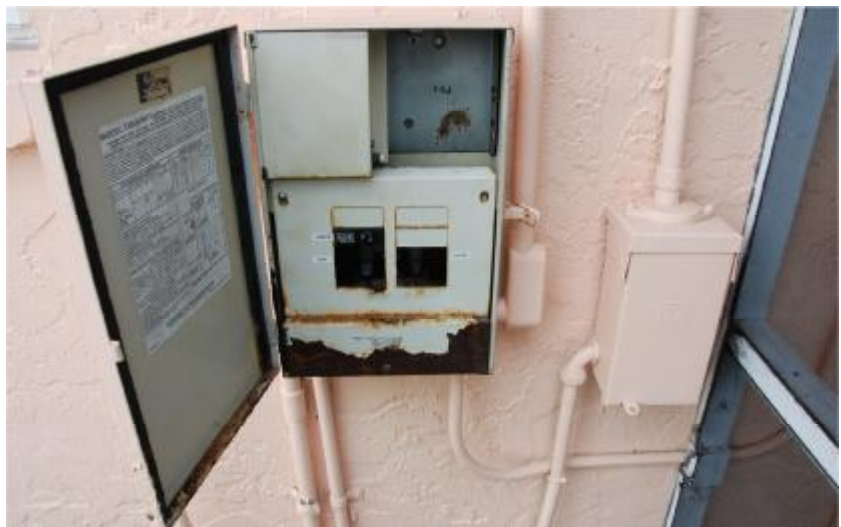
Safety Concern The old pool sub-panel East of the screen cage does not have any circuit breakers in it, yet it still supplies the pool light. Have an electrician evaluate this and make repairs as needed.

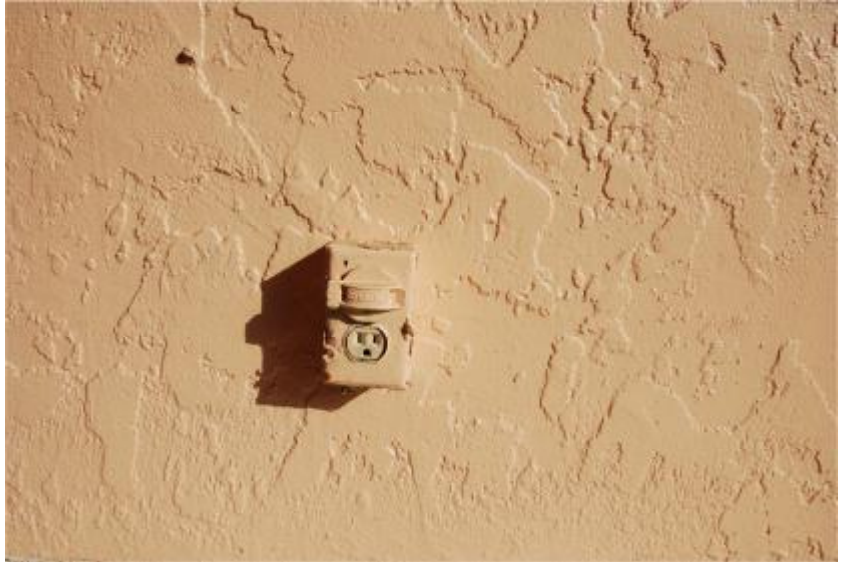
Safety Concern The receptacle on the front porch is missing part of its weatherproof cover.

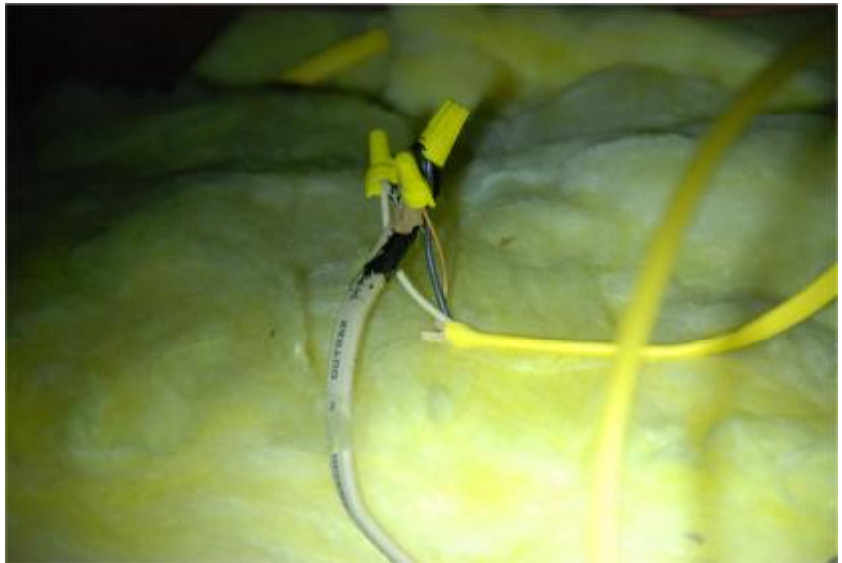
Safety Concern We found exposed wiring splices in the attic. All wiring connections are required to be enclosed in approved boxes to reduce the risk of fire that could occur in the event of a fault that might cause sparking or overheating. This is a potential hazard that can easily be corrected by enclosing these connections in approved boxes.

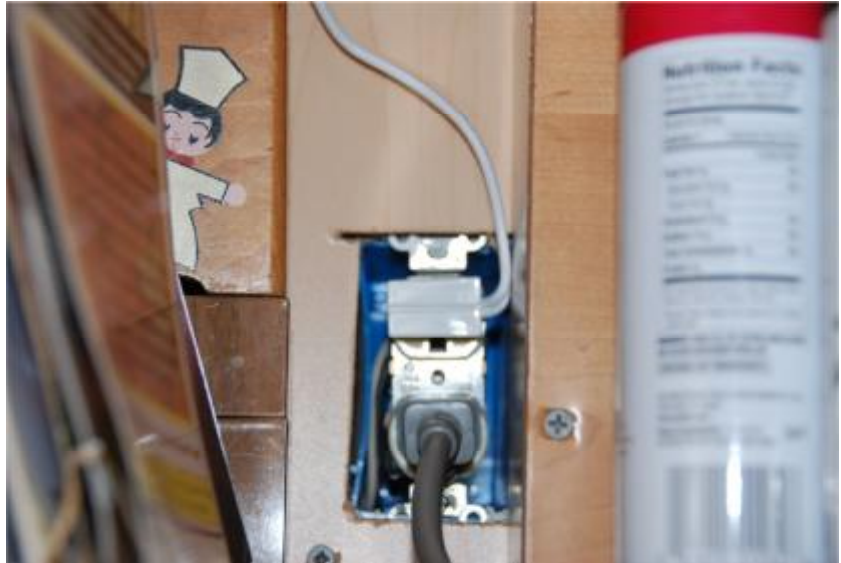
Safety Concern Have an electrician install proper wiring and receptacle cover at the cabinet above the microwave.

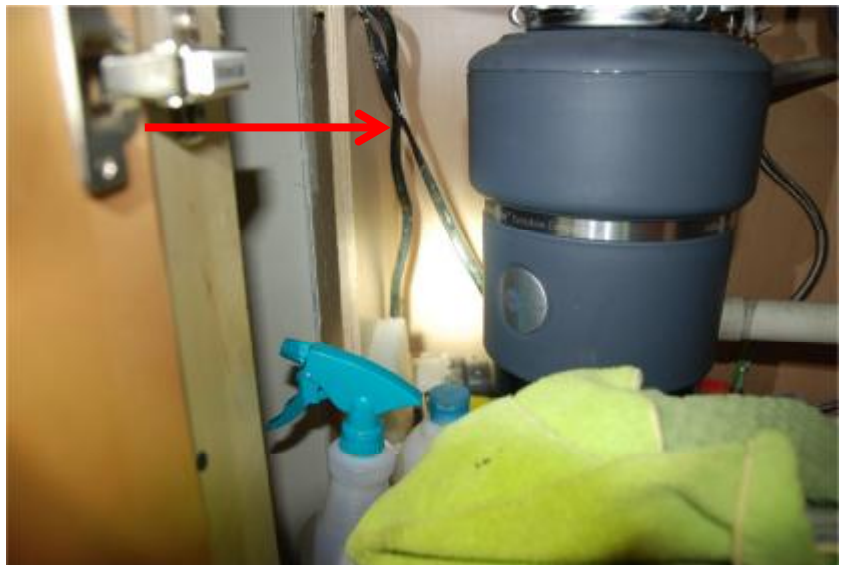
Safety Concern The nonmetallic cable to the disposer under the kitchen sink is not protected from physical damage as required for safety reasons. An electrician should install approved wiring. Cost is minimal.

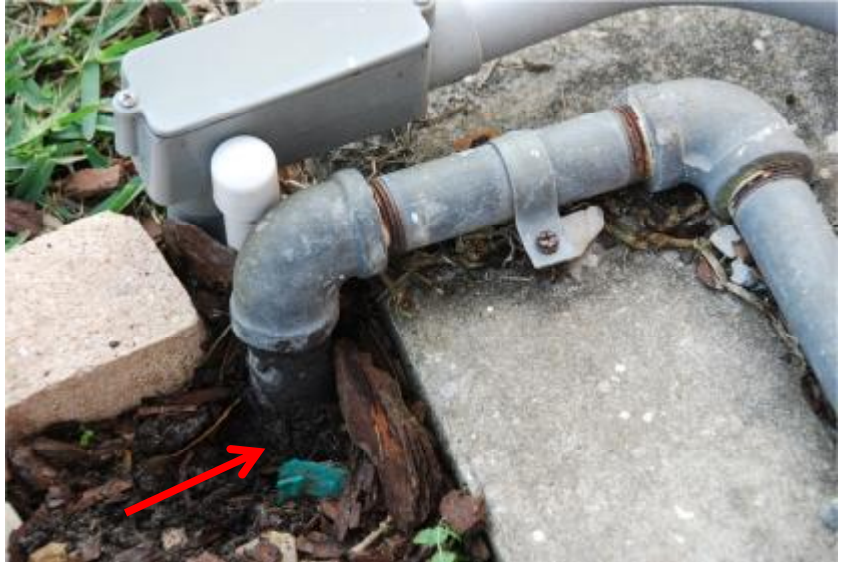
Investigate Further Metal gas piping is buried in the ground on the East side of the house. This feeds the outlet for a BBQ grill. Generally, this is a bad idea due to corrosion. The pipe has protective tape wrapped around it. Excavate and examine the condition of the metal piping.

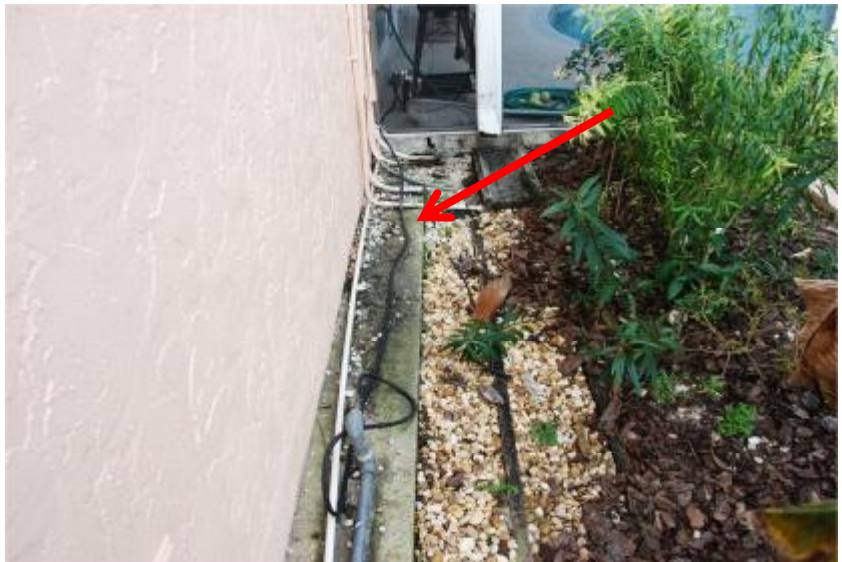
Safety Concern Metal gas piping terminates outside the pool cage. Multiple gas hoses are connected together to supply the BBQ grille. This is prohibited. Extend the gas line to the area of the grille.

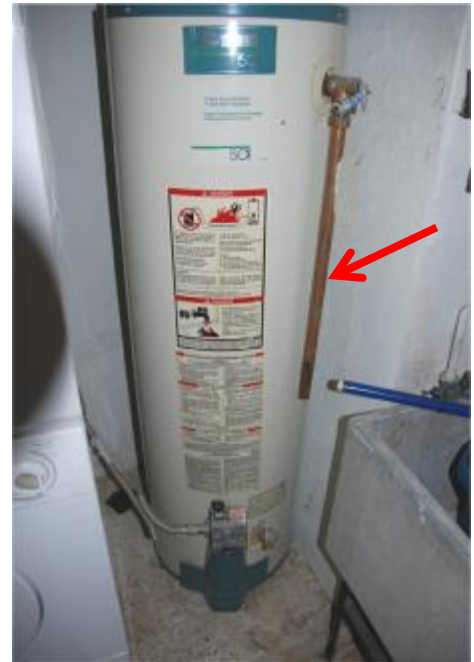
Safety Concern Piping from the water heater temperature/pressure relief valve should be extended to within 12" of the floor. In the event the water heater controls became defective and failed to stop heating, the steam and boiling hot water discharged would strike anyone standing nearby. Extension piping is required to be the same size as the valve. It may not be reduced. See the manufacturer's installation instructions for other requirements. Repair of this condition is inexpensive.

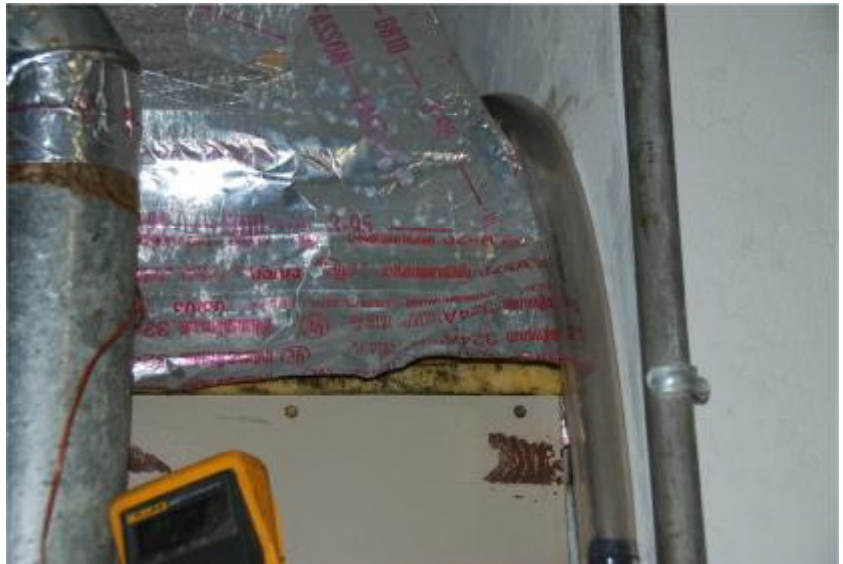
Minor Repair Duct joints at the top of the indoor evaporator coil are loose. Seal the joints to prevent air leakage.

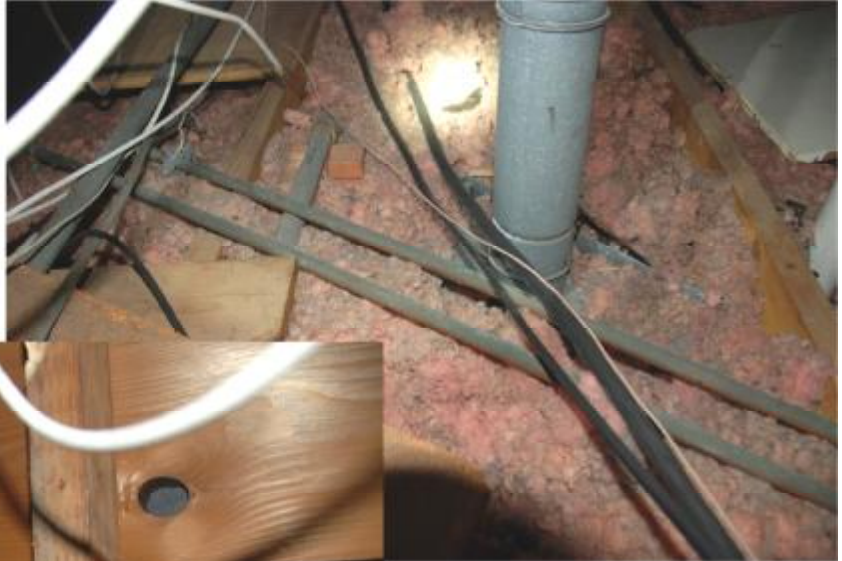
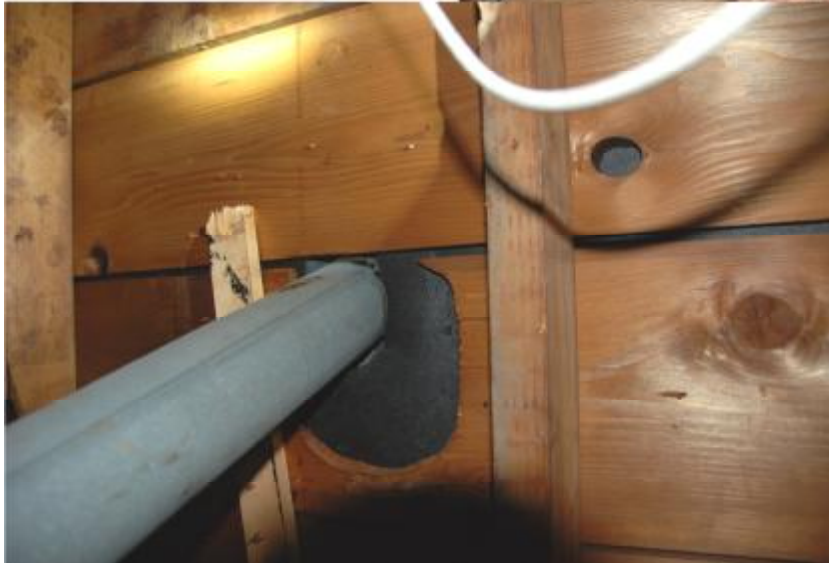
Safety Concern Roofing felt, electrical wires and insulation are in contact with water heater and furnace flues. The flues should be an inch away from anything flammable, wiring and insulation.

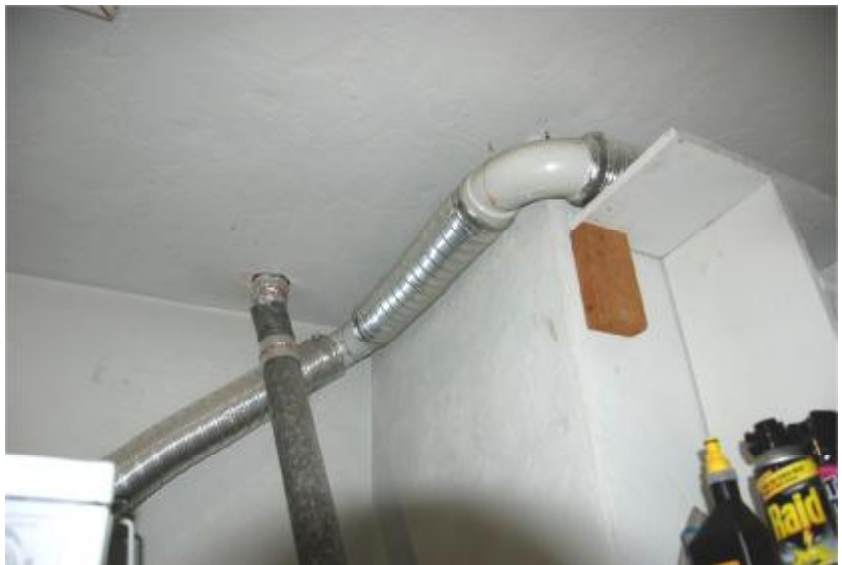
Safety Concern The dryer vent uses plastic parts and flexible connectors. This is unsafe. Install an approved vent. See appliance section for more information on dryer vents.

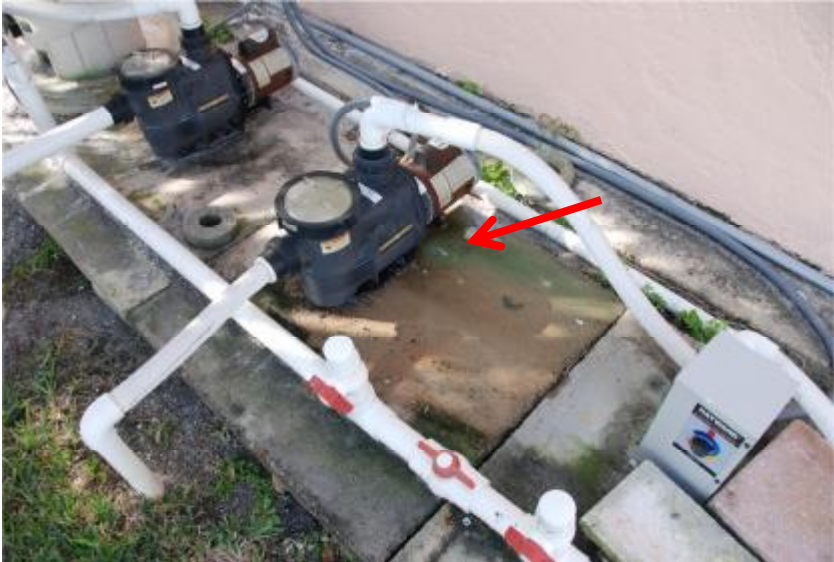
Minor Repair The pool pump is leaking at the bottom .

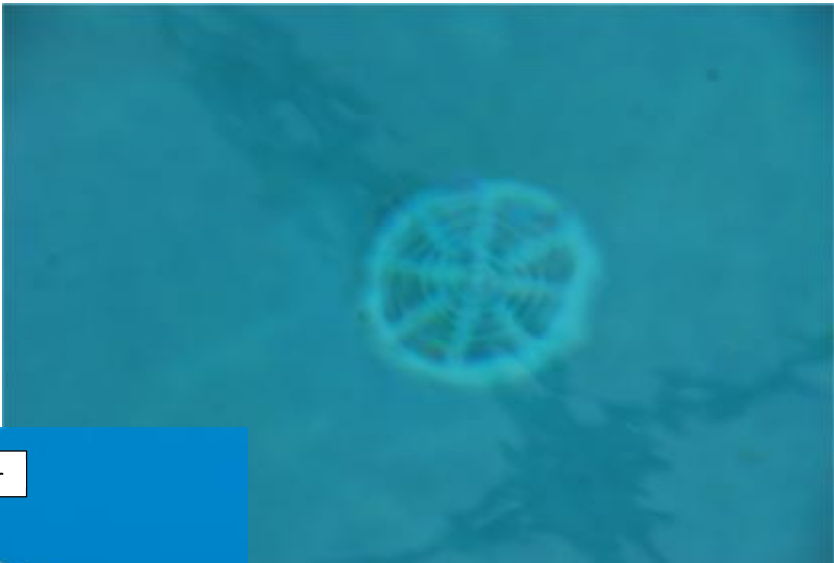
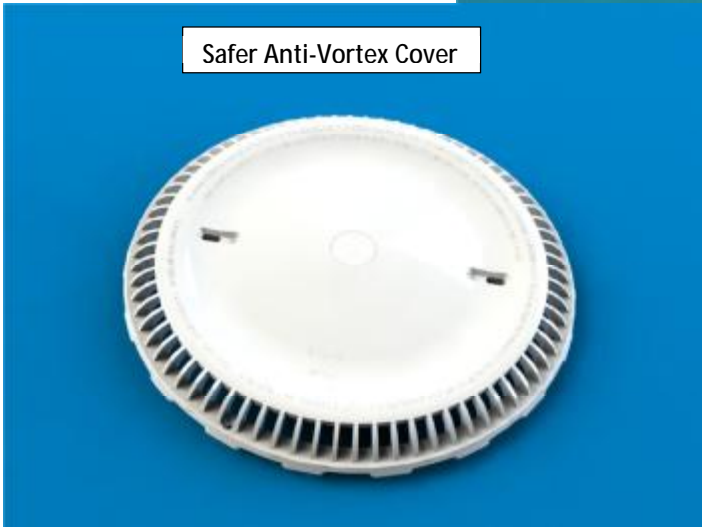
Safety Concern The main drain cover is an older type that may allow entrapment of bathers due to suction. Read this CPSC document: <http://www.cpsc.gov/cpscpub/pubs/363.pdf> Replacement with an anti-vortex type of cover is recommended to prevent this. Suction relief devices should be installed.
