Mark Cramer Inspection Services, Inc.

Building Inspection Report

Report Number: 90002785

Address: 123 Any Street, Clearwater FL 33785

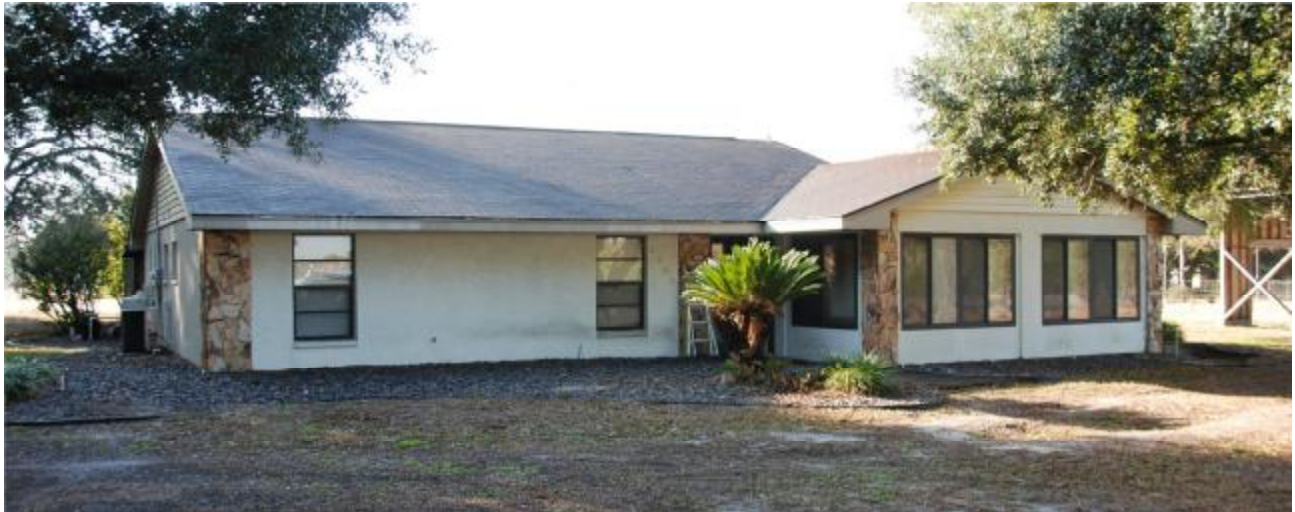
The inspected property is a one story ranch home with a screened back patio and pool.

The exterior walls are constructed of concrete block.

The interior and exterior surfaces have no signs of cracking that would indicate significant movement.
Typical small cracks are present.

Hairline size step shaped and vertical cracks were observed in the exterior concrete block walls. These are usually the result of settlement, and do not appear to indicate any structural problems at present. In a perfect world, properly constructed foundations and concrete block walls would not crack. However, cracking of this type is found in more than 75% of the homes we inspect. Usually the cracking does not advance beyond a minor stage, but the causes of the movement cannot be determined from visual inspection. Should any of this

cracking advance considerably in size in the future, further investigation consisting of foundation excavation, inspection, and soil borings would be warranted, and repairs could become necessary.

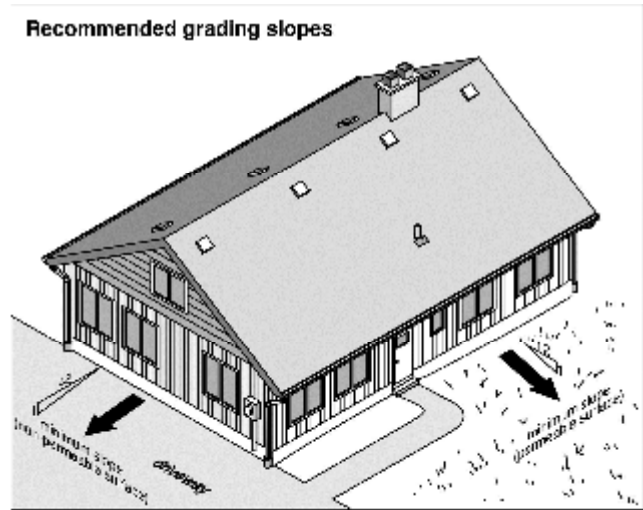
Grading is adequate in most areas. Minor adjustment is needed in some locations to divert water away from the foundation.

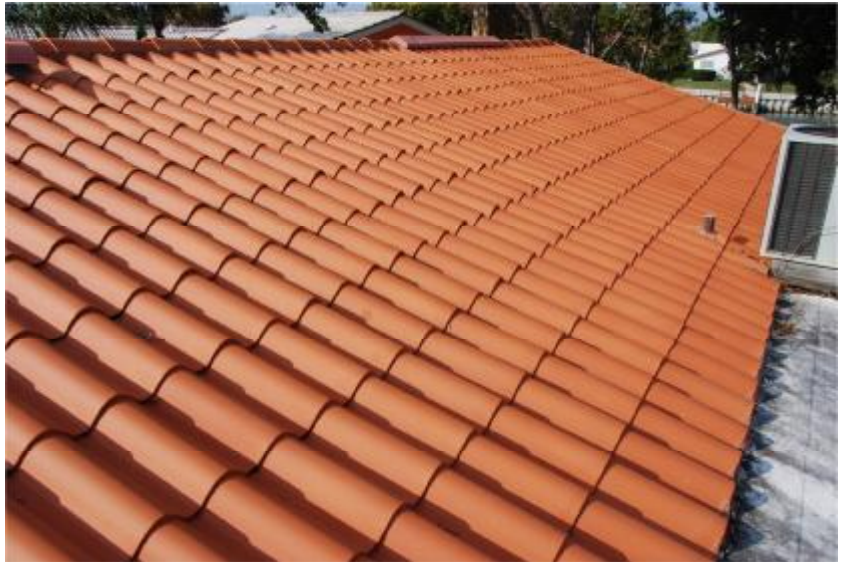
The roof covering is clay tiles adhered to a waterproof underlayment. Based on visible wear, its age was estimated to be eight to eleven years.

The tiles appear to be well fastened and aligned. None were broken or cracked. No evidence of slippage or movement of the tiles or sub-roof was observed. Flashings appear intact. Valleys are in adequate condition. The metal edge is intact. The inspector was able to get a good look at most of the underside of the roof sheathing while in the attic. No signs of active leaks were observed. The roof appears to be watertight at present.

We recommend that you ask the seller about the presence of any roof leaks, including past leakage. If repairs are needed, a licensed roofing contractor should make them.

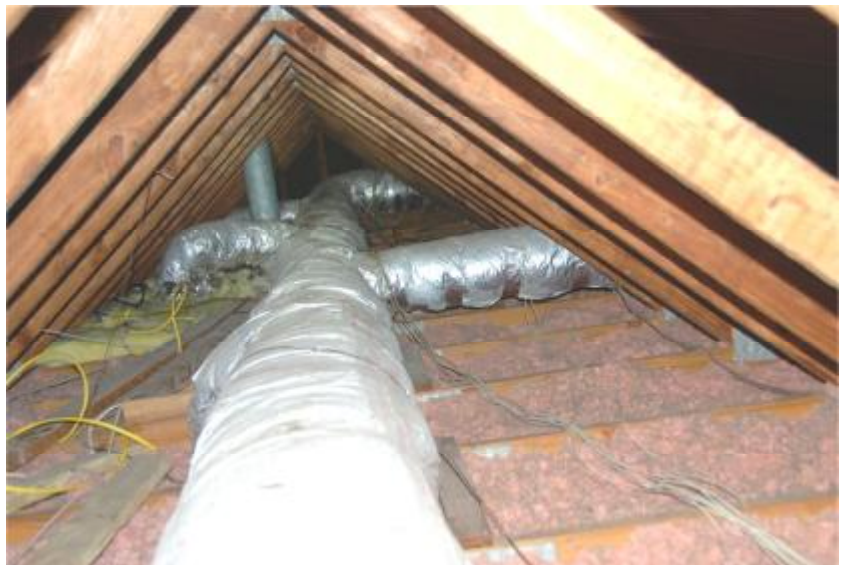
The condition of readily visible elements in the attic appears adequate except as noted elsewhere in the report. Roof sheathing and framing were examined and probed for signs of deterioration in limited areas. None were found except as noted elsewhere in the report.

We saw no evidence of leakage in the readily accessible areas.

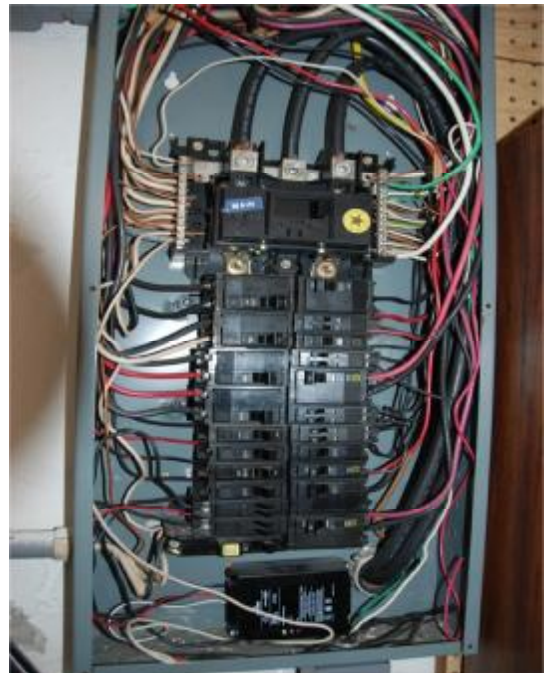
We opened and inspected all main and sub-panels. Conditions appear adequate except as noted below.

Electrical systems require regular maintenance for safety reasons. We recommend that you have a licensed electrician perform annual inspection and maintenance.

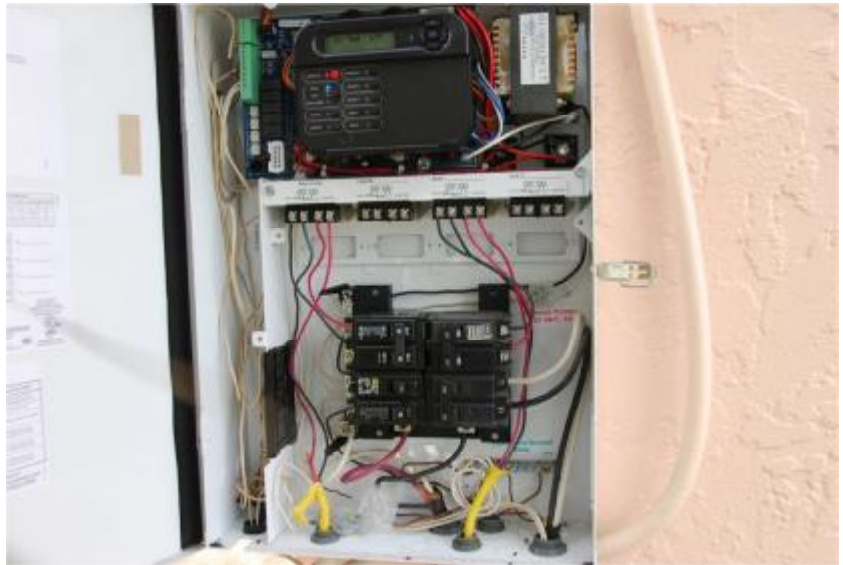
GFCI devices tested functional using a testing device. GFCI devices are not installed in all recommended locations. Upgrading is recommended.

Metal gas piping is not bonded. See repair list at end of report.

The pool equipment is not bonded properly. See repair list at end of report.

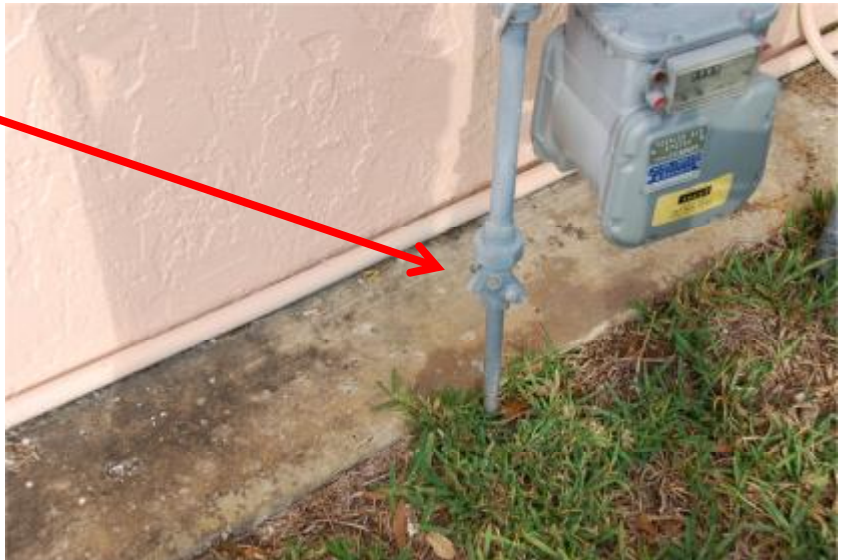
The main gas shut off valve is located on the East exterior at the meter.

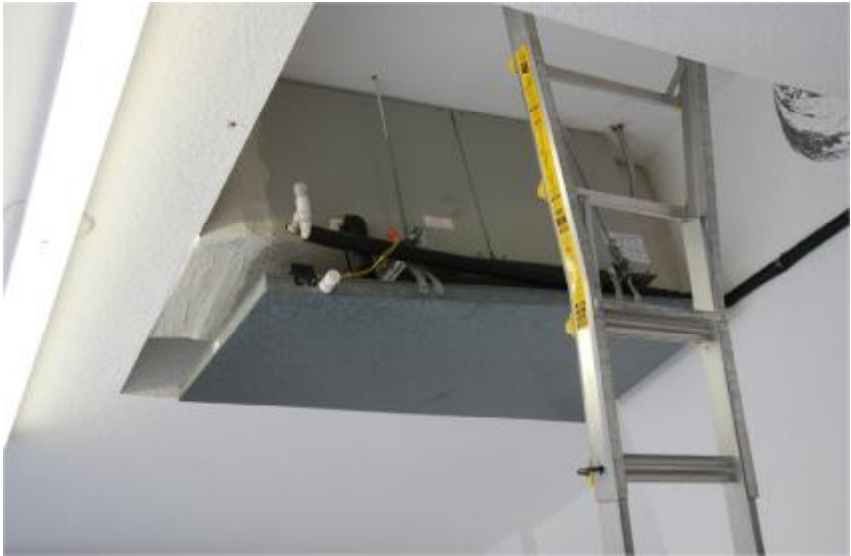
The estimated size of the system is three and a half tons.

The estimated age of the cooling system is ten years old.

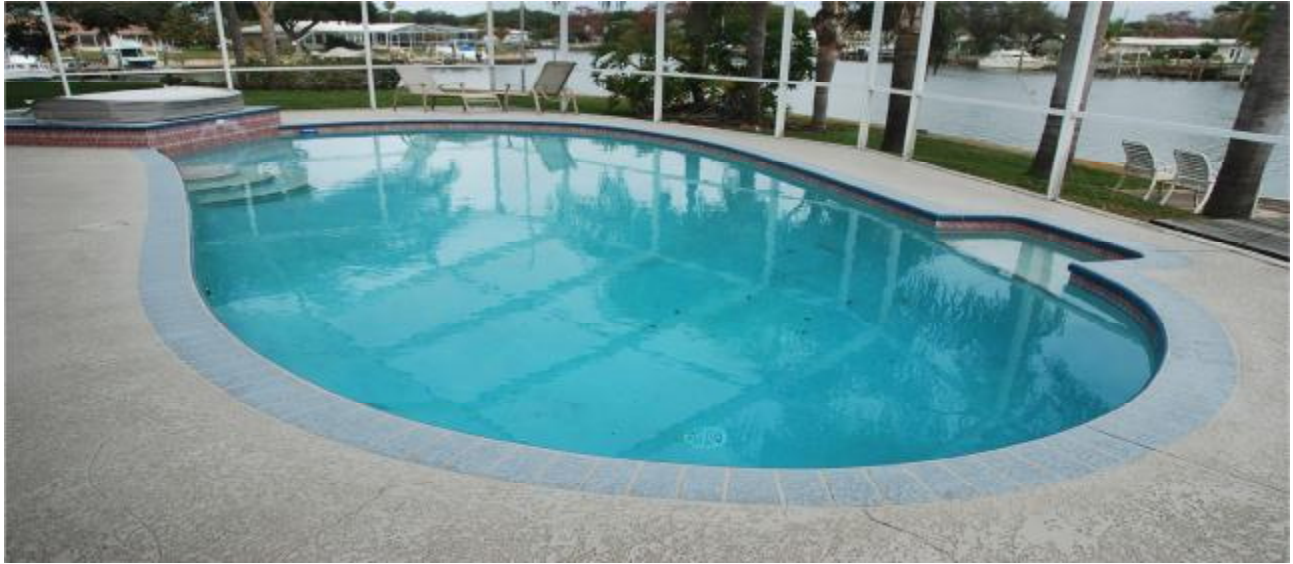
The pool is an in-ground concrete structure. The pool is surrounded by a concrete deck. A fiberglass spa is installed in the concrete deck.

The pump picked up its prime reasonably fast and ran without excessive noise or heat. Circulation of water appears adequate. The pool water was clear. Detailed instructions on pool maintenance can be obtained from a pool supply store.

The white surface of the pool is a marcite and quartz product. Marcite is a masonry product that is plastered over the concrete shell of the pool. The surface deteriorates over time. Typical lifespans range around eight to twelve years before refinishing is needed. The surface shows moderate wear. It remains in adequate condition.
